**These instructions apply only to machines equipped with MAC solenoid valves shipped before 2008**

Intermittent failure to actuate the collet closer with M12 or M13 on machines equipped with MAC solenoid valves shipped before 2008 can be caused by lower than normal computer power supply voltage combined with higher than normal voltage requirement on the MAC valve.

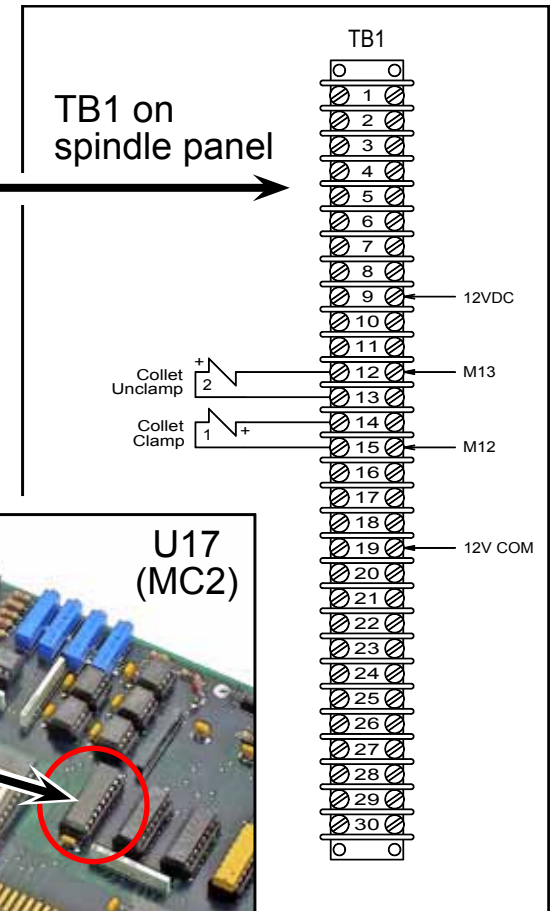
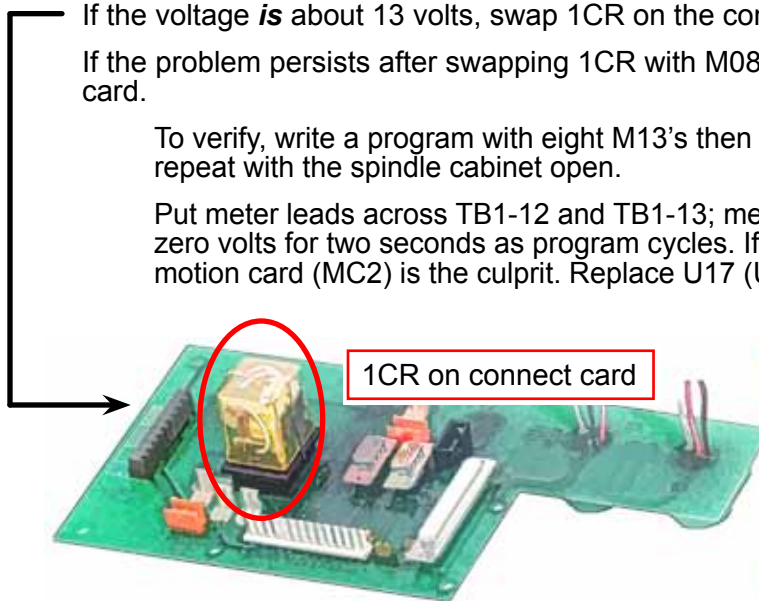
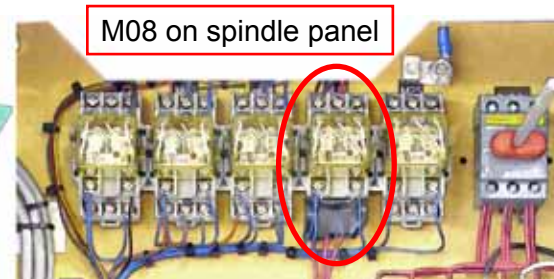
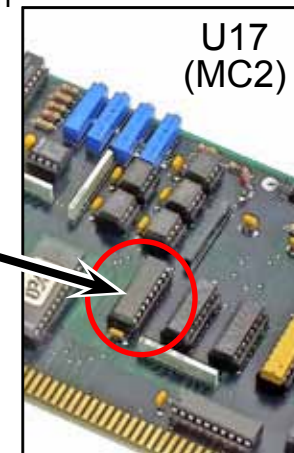
Put meter leads across TB1-12 and TB1-13; meter should read 11.5 volts for two seconds, then zero volts for two seconds as program cycles. If the voltage is 10 volts or less, the driver on the motion card (MC2) is the culprit. Replace U17 (ULN2803; available at DigiKey.com).

To verify that the voltage is good, open the spindle electronics cabinet and power up the machine. With servos on, and DC voltmeter leads on TB1-12 and TB1-13, meter should read at least 11 volts when collet open button is pressed. Move leads to TB1-14 and TB1-15: meter should read at least 11 volts when collet close button is pressed.

To verify, write a program with eight M13's then one G04F2 then M30. Run this program in cycle repeat with the spindle cabinet open.
